Buena Vista Coalition SDEAR Work Plan

Proximity to Surface Waters

Buena Vista Coalition
525 North Main Street
Buttonwillow, CA
April 15, 2016

**BUENA VISTA COALITION
WASTE DISCHARGE REQUIREMENTS GENERAL ORDER FOR
GROWERS WITHIN THE TULARE LAKE
BASIN AREA THAT ARE MEMBERS OF A THIRD-PARTY GROUP
Order R5-2013-0120**

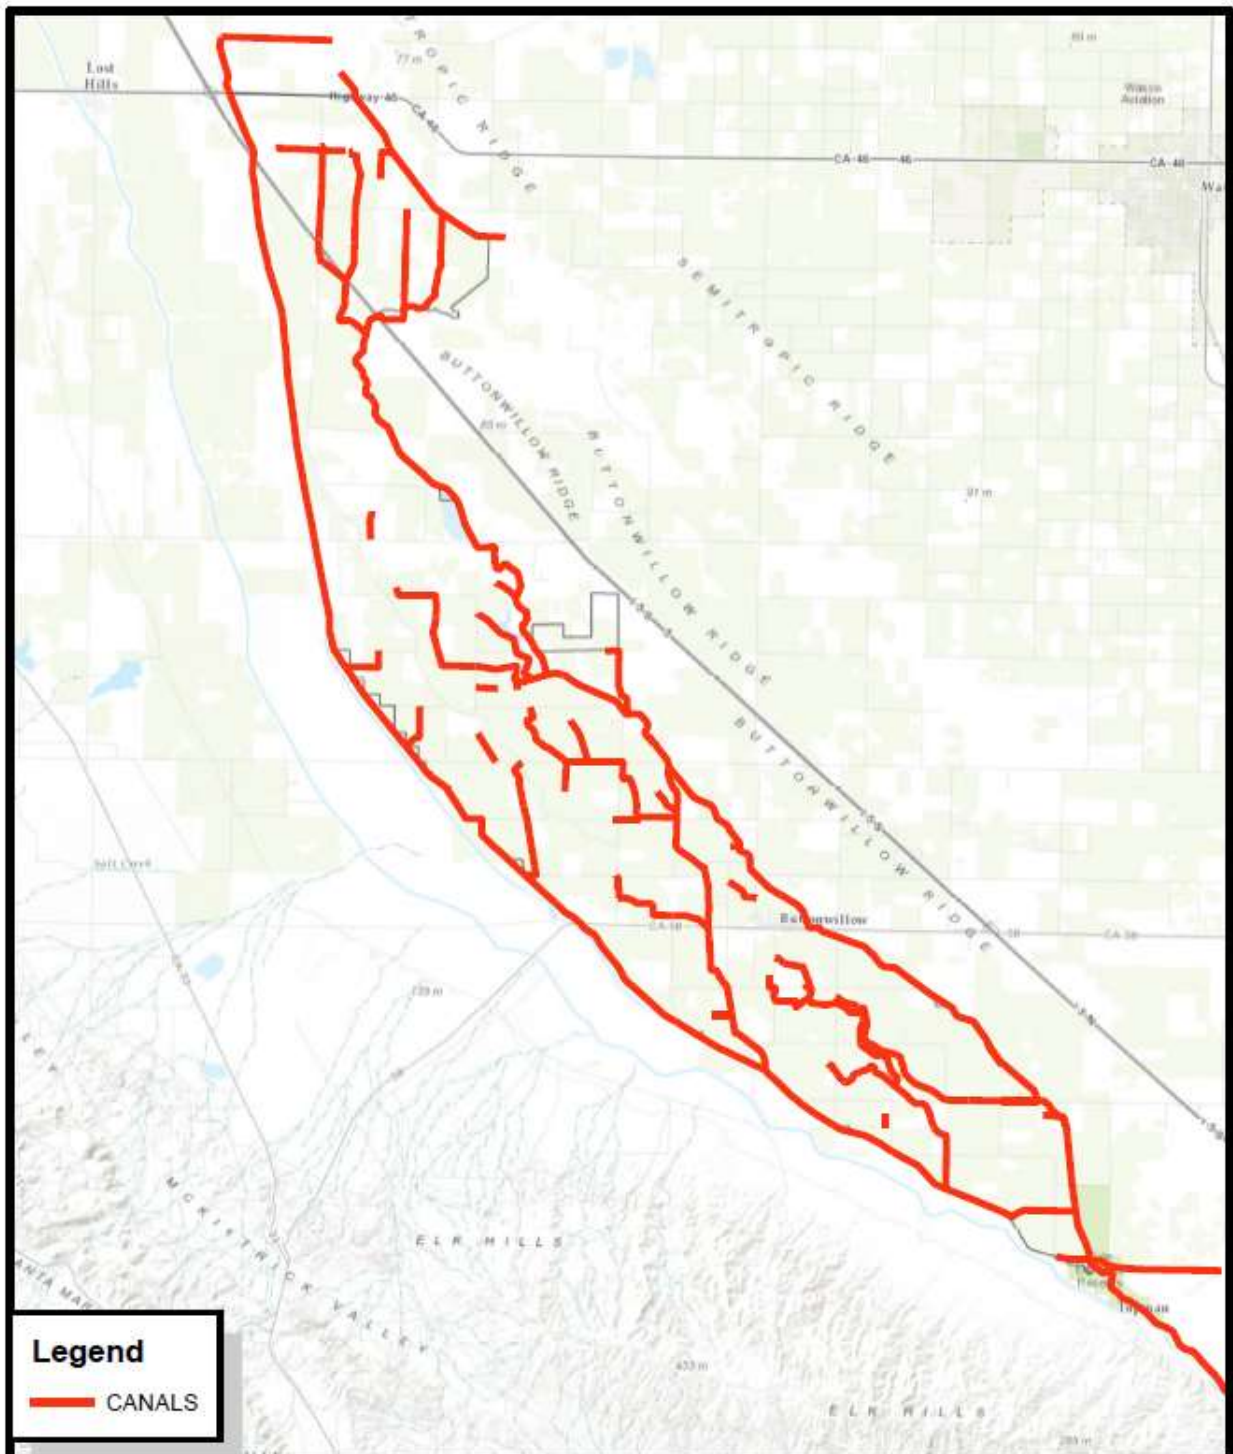
DISTRICT CANALS

As the irrigation system was built back in the 1870's, long before pumps, supply canals all were built at elevations above the farmland, so water could gravity flow onto the fields for irrigation. The irrigation system continues to operate this way, so field water cannot flow back up into the canals, it can only flow down into the drains. Attached are plans showing the BVWSD Drains, BVWSD Canals, and the BVWSD Canals and Drains combined.

The Buena Vista Water Storage District and lands of the BVC are set up like a two story house with a basement. Water enters the District in the Eastside and Westside Canals. Water is delivered from these canals to smaller canals. All canals supply water to fields. Some fields using furrow or flood irrigation techniques have surface run-off water which go into drains. The canal is the upper floor of the house, with an elevation higher than the adjacent fields, as almost all fields are supplied water from canals by gravity flow. The field is the ground level floor. The drains are all below field grade, so the drain water gravity flows from the field into the drain which is the basement. Water cannot flow up from a drain into a canal. All drains connect and feed into the Main Drain Canal. (Note: this is the only drain which is called Canal, as it is more than a tailwater drain.) In addition to no water leaving the BVWSD in the Main Drain Canal, the Main Drain Canal has many control structures which would enable sediment to settle out of the water and settle in the Main Drain Canal. But water cannot flow into the Kern River Flood Channel Canal, the Eastside Canal, the Westside Canal, or any other canal from adjacent fields.
